Boston & Maine Pullman Car No. 1246 Update

text & photos by David Woodbury

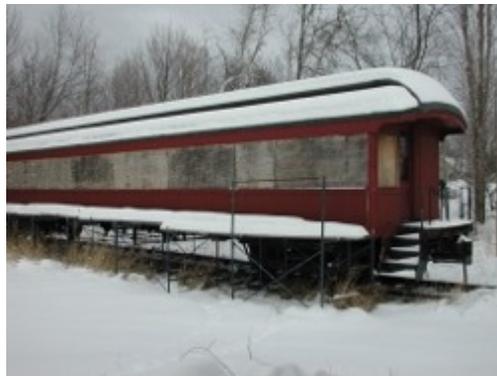
An exterior view of No. 1246 today, showing the staging set up in preparation for window installation when the weather warms up.

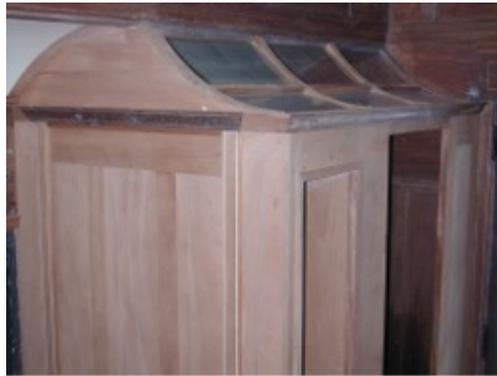
Ceiling of the women's saloon with glass in place, but not yet frosted.

This prepared me for my own replication project which began with making a pattern for the ceiling curvature. This curve had to fit into the mahogany panels on each end wall, so I was not free to establish my own radius. In fact the curve was close to, but not exactly, a constant radius. This meant a lot of try and fit before I got the pattern right. Luckily the curve was the same on both ends of the car. Once I had the curve right, I had to make a "window" with curved sash in one plane and flat in the other. The glass would be flat fortunately.

To make the curved sash from one piece of mahogany would have created an almost criminal waste of a valuable resource, so a solution was to laminate some scrap and that worked out well once I established which plane the lamination should follow for maximum strength (vertical, not horizontal). The walls were mortised and tenoned out of 5/4 mahogany with inlaid veneered panels. The inlay was a rather simple black and white made from maple and "ebonized wood" laminated and sawn into thin strips. The doors and trim will have to wait for the finished floor before their final size is apparent. Each panel has its own trim between it and the stile or rail it sets into and each saloon has molding above the door, both inside and outside. To top it off, each end wall on the outside (outside the saloon, but inside the car) carries a beveled glass mirror so a frame for each had to be made. At one point I tried to count how many individual pieces went into each saloon, but I gave up after about 150. It should be no wonder that this effort took a good portion of the summer, longer than I estimated by far.

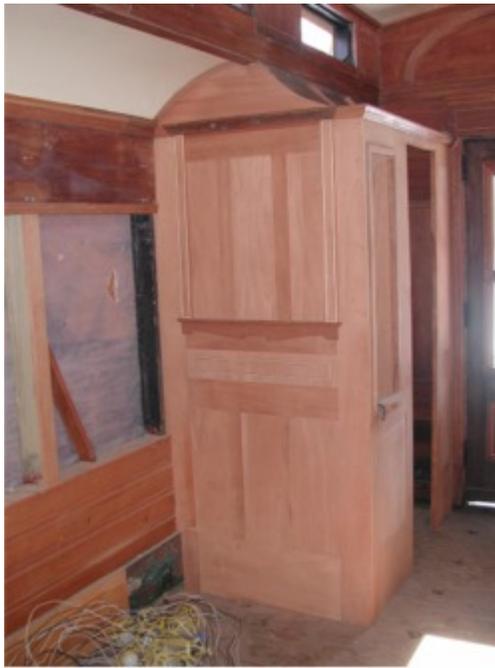
**Completed women's end saloon.
Note pocket on saloon front to hold
water canister. Men's end has a
small cabinet for wreck tools on the
inside of the door.**

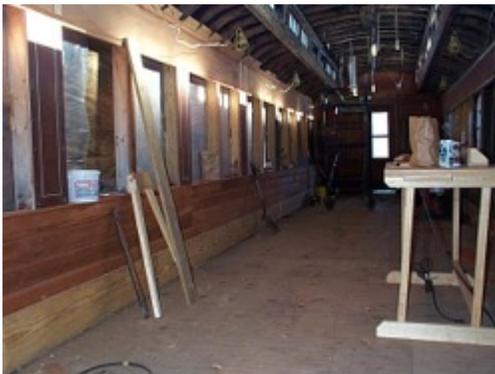
It was into early autumn when I could turn my attention to the next big area of work for the year, the ceilings. The original material was simply stated to be "composition board" and it appeared to be a heavy paper or cardboard, not corrugated. None of it was salvageable due to water damage. It's replacement had to be flexible enough to take the curve especially on the lower roof over the seats and rigid enough not to sag on the longer runs of the monitor roof over the center of the car.

**The interior of No. 1246 last year,
before replacement of the ceiling.**

The material that best fitted this requirement is hardboard. Masonite is one of it's trade names. Hardboard comes in two styles, tempered and untempered. Untempered is more flexible, has a less finished appearance and is harder to find. Tempered won't take the more severe curve of the lower roof, so I shopped around for the untempered. I used 1/8 inch for flexibility, but might have been better off with 1/4 because of the greater ease of countersinking and hiding the fastening screws. For those seams that wouldn't be covered by the original style strips or battens, I used a flexible caulk. Commercial joint compound might have offered a smoother finish, but I was suspicious that it wouldn't be as flexible. Thanks to Linn Moedinger for the suggestion. Priming and painting with a paint that followed the original came next and represented the first finish work on the project.

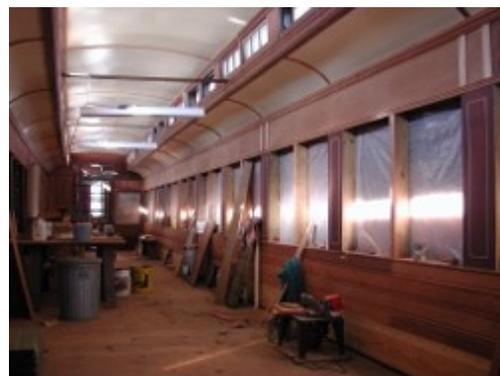
**Interior view showing ceiling and
overhangs, installed this past fall.**
