## The Continuing Saga of ex-Boston & Maine Coach No. 1246

(Part VI)

story and photos by David Woodbury

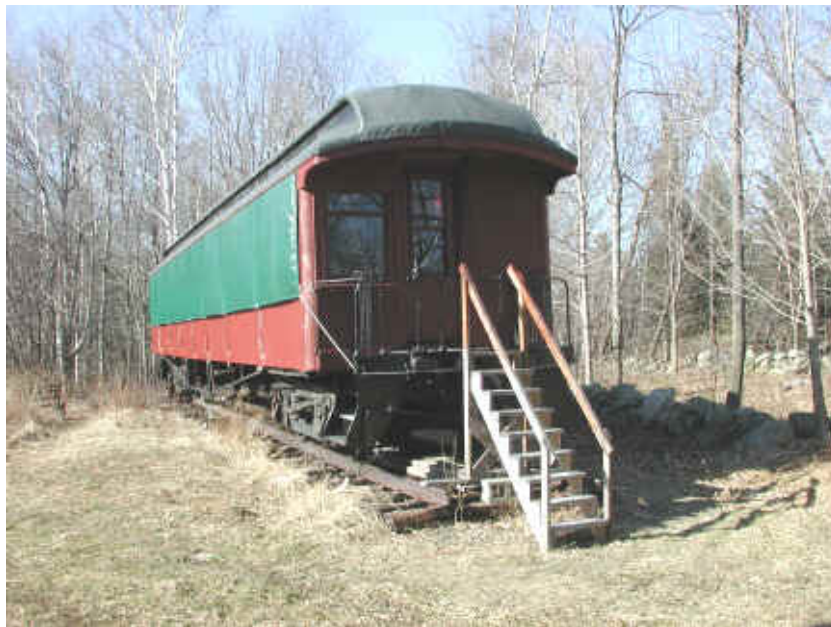
*The new steps, side curtains and a corner post in need.*

Stairs aren't something you just knock together. There's a sort of science to it. The combined total of tread and riser has to be to a certain figure which my home handy man book doesn't give, but which I estimated at about fourteen inches. The angle of the stringers have to be such the stair risers are all the same height after the treads are nailed. This means you have to know the vertical rise and plan ahead so you don't have a half step at top or bottom. Calculating the vertical rise to uneven ground a number of feet out from the platform is no easy trick.

I found that the easiest way to cut the notches in the stringers would be to make my angle forty-five degrees and did so for this reason. Only after the whole thing was completed, did it seem that this was a little steep. All in all, the project was a success with this slight exception. At last I could run up and down and actually carry stuff around. This was all to the good

However, varnishing was not the only way I spent the summer. There was also the matter of the corner post. For some reason on wooden coaches, the corner posts always take a beating. These are the large quarter round pieces at each corner that transition the sides to the ends. The ones I've seen closely, are ash as are the window sills and window trim. Not the best of woods for rot resistance, but acceptable if maintained. Rot damage forms at the lower edges of the car first and these corner posts were no exception.

It wasn't helpful that they had been pierced for large wood screws during construction and plugged. Two of the four seemed solid enough, but two needed some attention. In fact, I could and did, inadvertently, put my finger through one of them when looking it over. Making a quarter round of this size, 4 or 4 1/2 inch radius is no easy thing and is compounded by how long it must be.

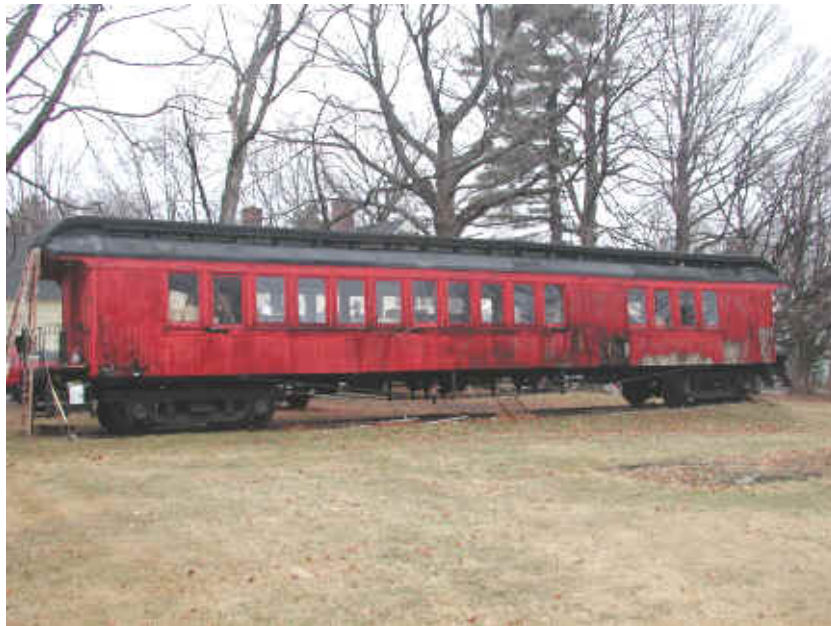
*OC&N; coach in Lunenburg, MA. Lots of work ahead, but an easier job than mine.*

As luck would have it, another car turned up in Lunenburg, Mass. Ex-B&M; 1286 a Laconia product had been sold as surplus by the B&M; in the 1970s to a buyer who moved it to his property in Lunenburg. During his lifetime it was never restored and became a catchall for all kinds of stuff. Of course, it suffered from neglect over the years as well. After the death of the purchaser, his family sold the home with the car and the present owner, not a railfan, but aware of the historic interest the car possessed agreed to give it to the **Old Colony and Newport**, a volunteer operated scenic railroad in Newport, Rhode Island which already operated two wooden coaches.

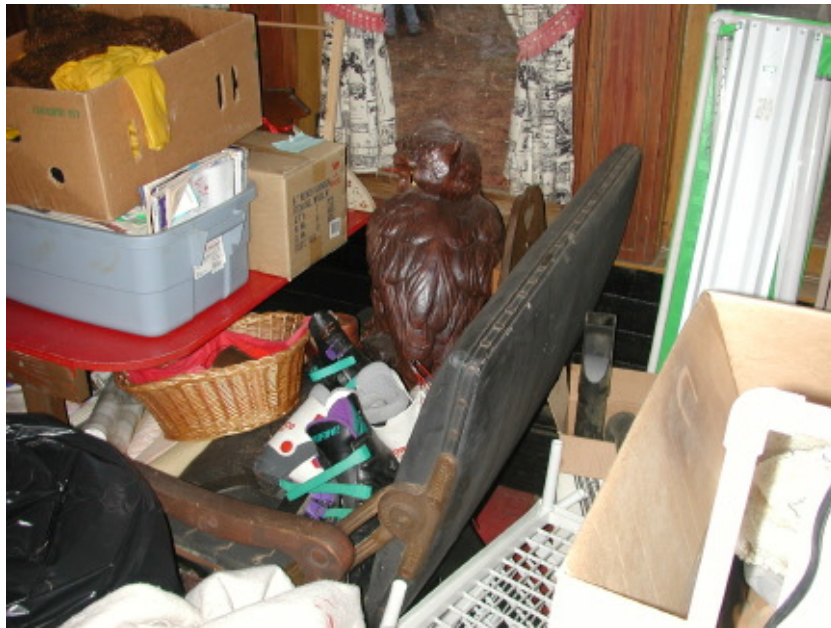
*Everyone has lots of the other stuff, but who has thirty plus seats like these? Ex-B&M; 1286.*

I saw the coach interior with personnel from OC&N; and noted that there were some real gems still left inside. These included a couple of correct style flip-back seats which OC&N; plans to use to replicate others. The two saloons had been ripped out years ago, just as mine had, but a crude enclosure for a chemical toilet had been built in the middle of the car against some blocked off windows. By the greatest luck, the original saloon door with all hardware was taken from the women's room and reused here.

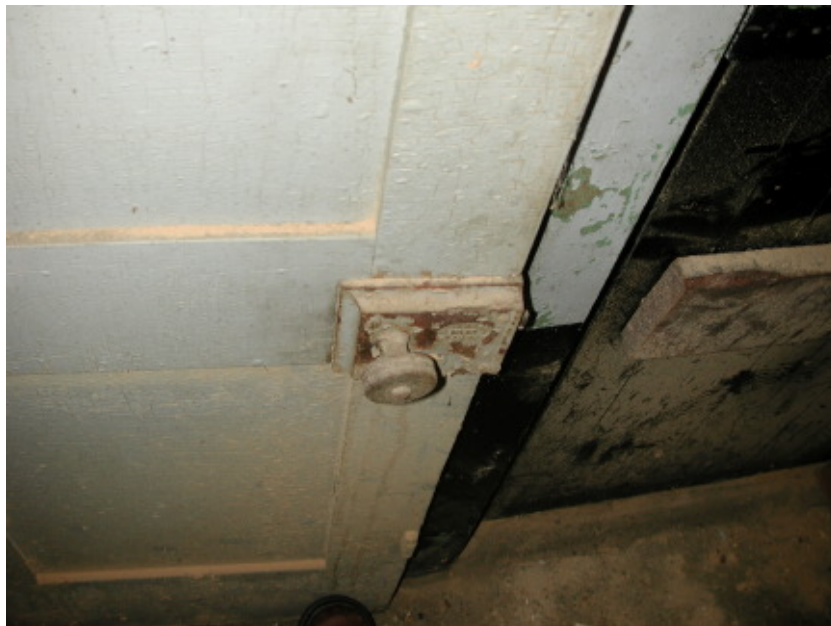
*Saloon rimlock as I found it in Lunenburg, MA. All photos by David Woodbury.*

OC&N; had no plans to replicate the saloons when they put 1286 into service so I begged for the door and hinges and most importantly, the latch. They graciously agreed and I took the door and hardware. I want to thank them again publicly for their generosity. I had no plans for the door

itself, but I could most definitely use the hardware. After stripping the lock, I found it was a Sherburne #53 marked specially for the B&M.; As such it would be keyed alike with the outside doors. The hinges, which had never been exposed to the weather, retained under layers of paint, their original japanned black finish. I was able to find a second set of the correct style hinges for the other door, but I'm still looking for another Sherburne #53. Not that I'm that hopeful.

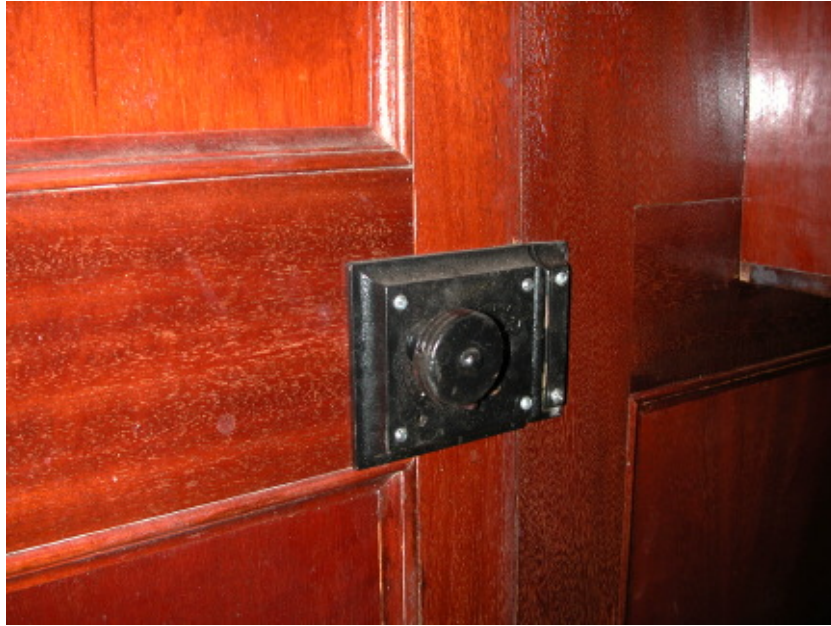
*Same rimlock as it now is.*

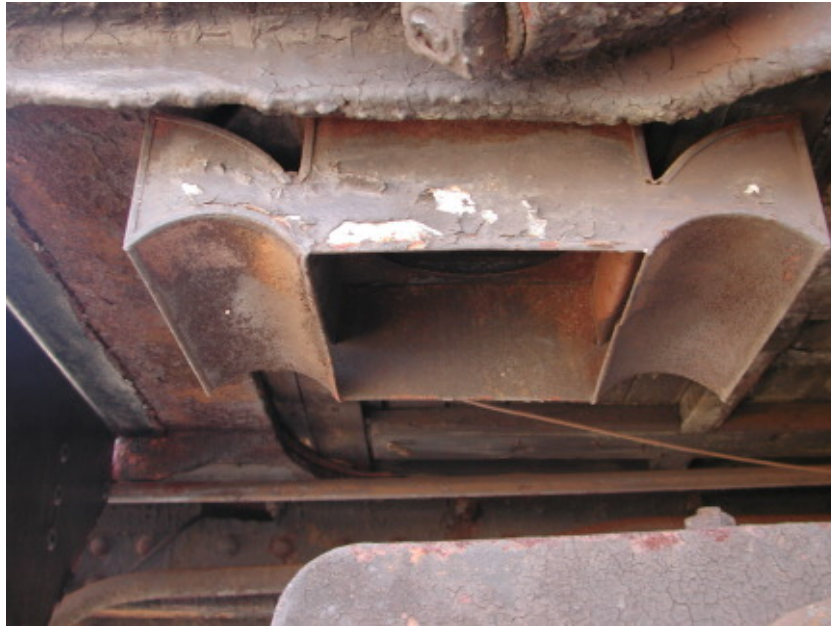
*Cute little venturi for downdraft, unfortunately placed over truck frame.*

Now was the time to think about cutting the holes for the hoppers. Before doing this, I checked under the car to see what guidance I could get from whatever remained from before. There is a cute little venturi under one end that gives a clue as to where to cut the hole. Unfortunately the venturi doesn't line up with the hole in the sub-sub floor so this interesting misalignment must have created some problems for the car maintainers who had to clean up after each run. Another interesting aspect of things was the fact that the frame of the truck was under the hole. If not directly under, at least enough to cause a problem on curves, oh well.
