Boston & Maine Pullman Car No. 1246 Update

text & photos by David Woodbury

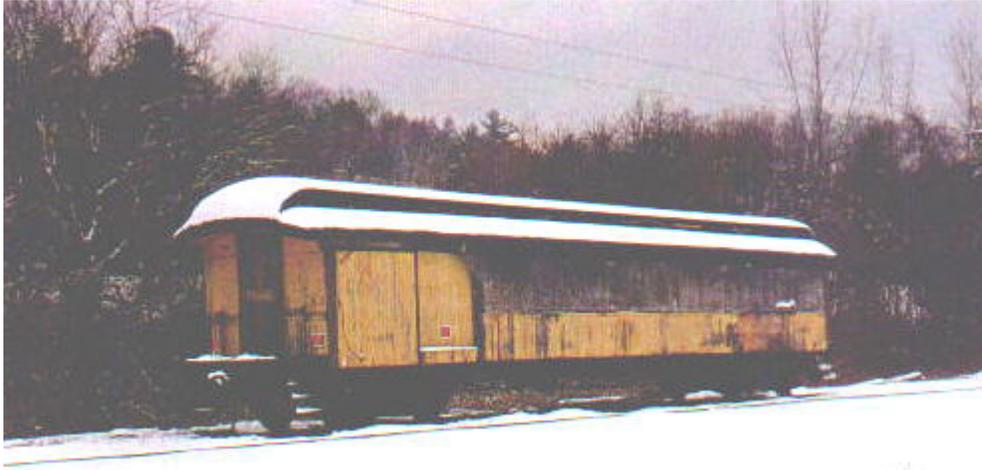
9 years ago No. 1246, then lettered Monadnock, Steamtown & Northern No. 243, was a rotting derelict, one of the last cars remaining at the old Steamtown site in Vermont, seemingly unwanted by anyone and a prime candidate for scrapping.
